## CASE STUDY

## **Plexipave**

PLEXICUSHION PRESTIGE - VELOCITY BLUE & TRUE BLUE

BROOME TENNIS CLUB BROOME, WESTERN AUSTRALIA

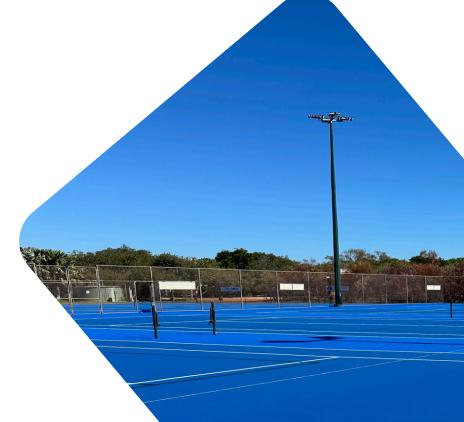
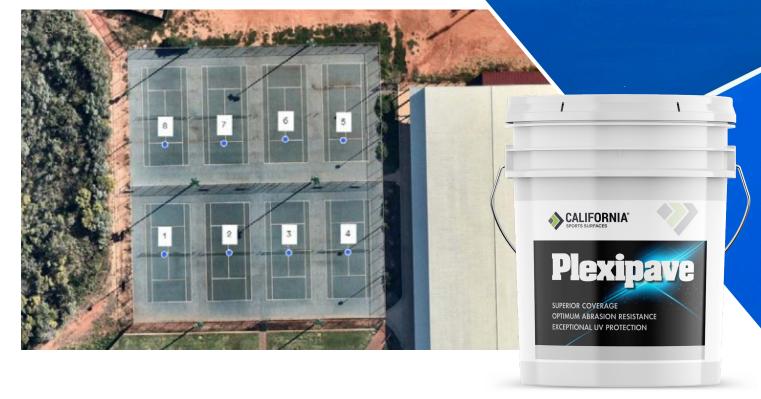
Broome Tennis Club is an exclusive development in Western Australia. With eight tennis courts degrading and in poor conditions, Broome Tennis Club was eager to repair and resurface the courts.

Cracks in the asphalt and road base below were repaired and sealed to prevent the ingress of moisture and further damage. Plexicushion Prestige was then applied as the new surface coating. The new cushioned surface provides shock-absorbing properties that will respond to the body impact and reduces fatigue on the legs, knees, ankles and feet of the players.
